GOLDEN EAGLE LAKE DAM

MONTGOMERY COUNTY, MISSOURI

MO. 10920

# PHASE 1 INSPECTION REPORT NATIONAL DAM SAFETY PROGRAM

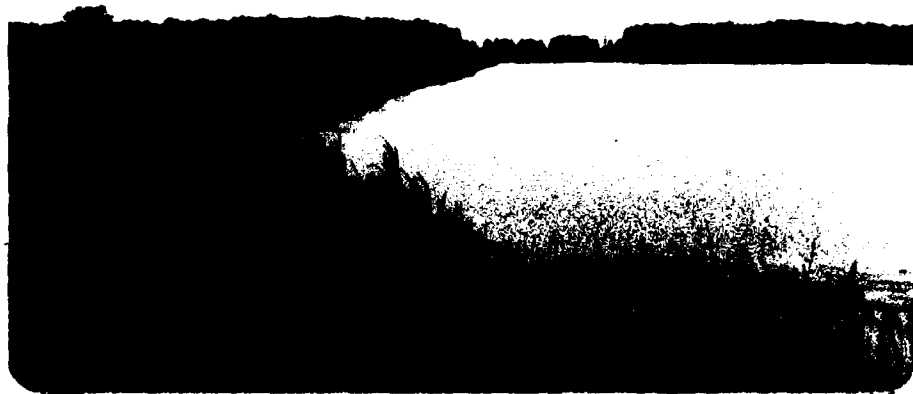
- (2) Upstream Slope. The upstream slope looks very good. It is well riprapped with durable limestone up to about elevation 820 (emergency spillway elev.). Nominal size of riprap is 8 to 12 inches. The slope is well vegetated above the riprap. A few small trees are growing at the water's edge. No rodent holes, slides or deformations were noted on the upstream face.

PHOTO NO. 2 - UPSTREAM SLOPE FROM LEFT END

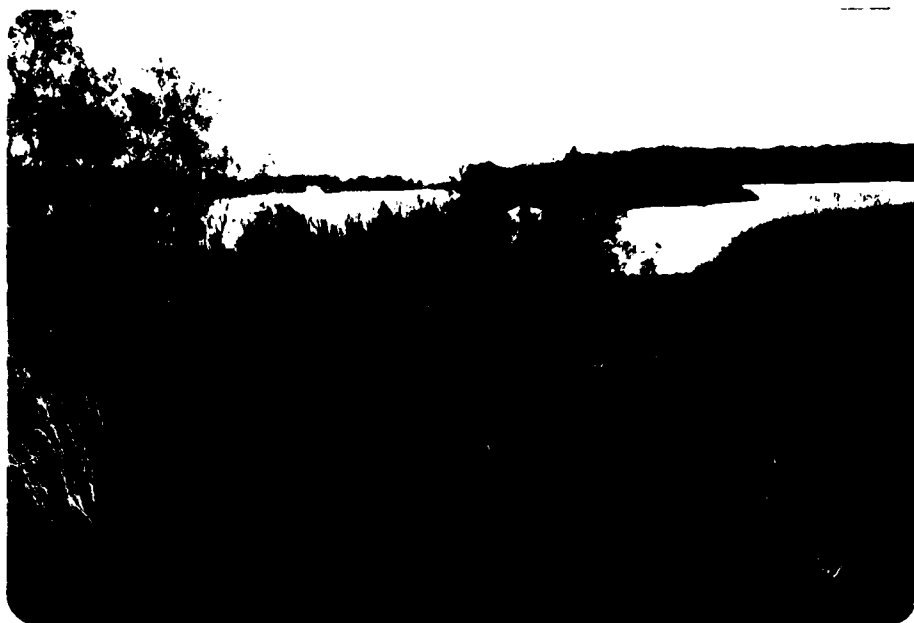
- (2) The emergency spillway is very well vegetated throughout its length. There are a few small trees and brush growing in the inlet to the spillway. No slips, slides or erosion was apparent in the spillway bottom or on the sides. Clay (CH) soils are present in the outside channel bank. The trash line in the entrance channel indicates that the reservoir level has approached spillway operation. Discharge from the emergency spillway should not endanger the safety of the dam. There was no evidence of flows through the spillway.

PHOTO NO. 6 - LOOKING UPSTREAM IN EMERGENCY SPILLWAY

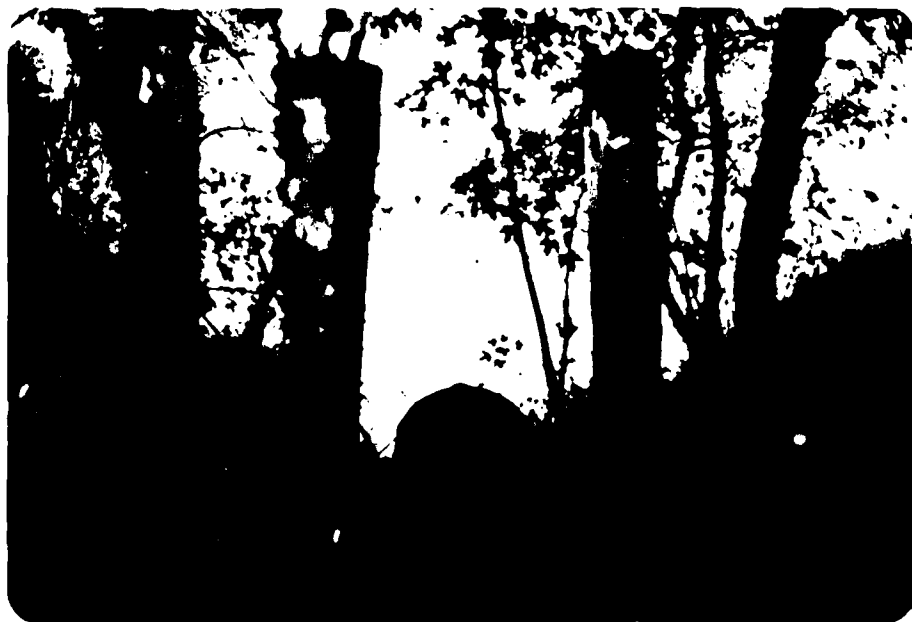
- (1) Principal spillway. No deterioration was noted in the steel riser or the outlet pipe. The inlet was clear and open without trash. The scour hole at the outlet end was eroded into CL or CH soil and appeared to be stable. The reservoir level was about 4 inches below the inlet elevation of the riser when inspected.

PHOTO NO. 9 - OUTLET END OF PRINCIPAL SPILLWAY AND  
SCOUR HOLE

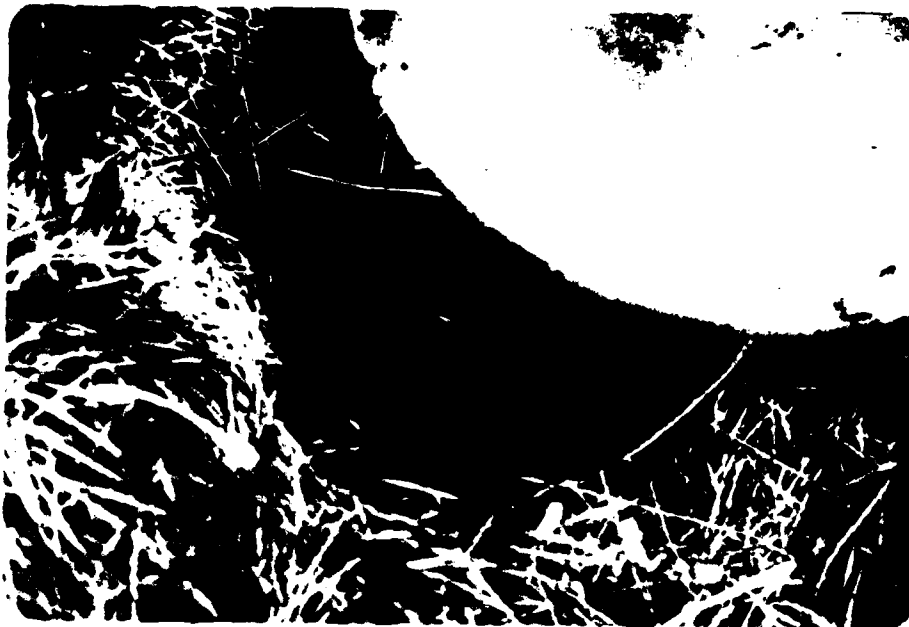
- (3) Drawdown facilities consist of a 6 inch diameter cast iron pipe passing through the embankment just left (west) of the principal spillway pipe. A valve is located at the lower end. The valve appeared to be operable and was barely dripping.

PHOTO NO. 10 - VALVE ON DOWNSTREAM END OF DRAWDOWN PIPE

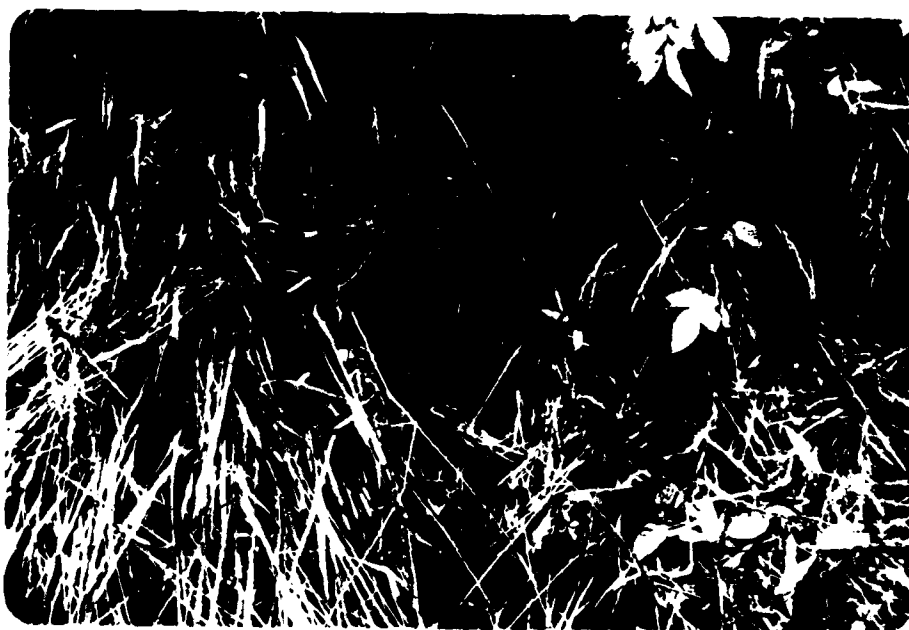
PHOTO NO. 11 - OUTLET END OF DRAWDOWN PIPE
